APPENDIX

C-1 *HYDROGEOLOGICAL ASSESSMENTS*

Re: Groundwater Supply – Drilling and Test Pumping of Well TW-02, New Maryland

As requested, BGC Engineering Inc. (BGC) is pleased to provide you with the following final report for the above-noted study relating to the Arsam Wellfield in New Maryland, NB.

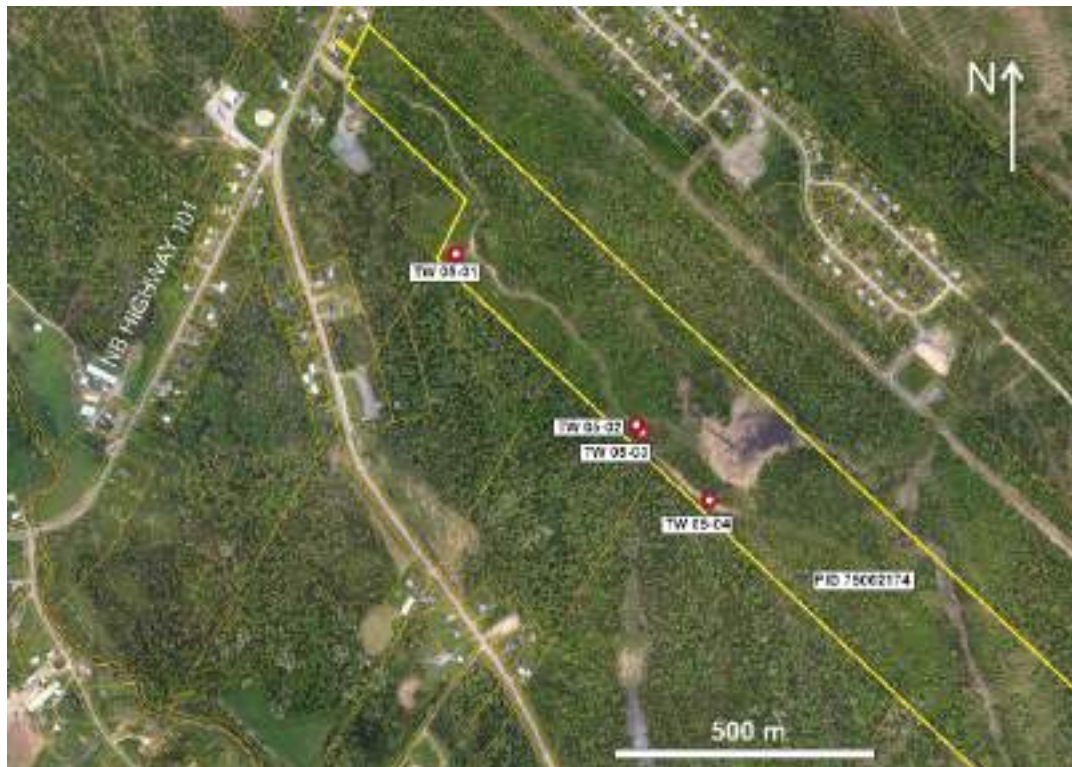
Figure 1 – Property Location Plan

On behalf of the Village of New Maryland (VNM), NB, Opus International Consultants (Canada) Limited (Opus) retained BGC Engineering Inc. (BGC) to provide hydrogeological support in the further development of the community's municipal groundwater supply. In this latest phase of the work an existing well (TW 05-02) on the Moomena property in New Maryland (PID 75062174, Figure 1) was deepened and a pumping test was carried out.

The constant rate test began at 1:40 pm on February 27, 2017, following the (almost) immediate recovery of the pumped well from the step testing. Water levels in the pumped well and in three observation wells (TW 05-01, 03 and 04 in Figure 1) were observed. The initial static water level in the pumped well (TW 05-02) was not measured, but was later assumed to be 3.376 m above the top of the casing, as measured after the test. The pumping phase of the test continued for 72 hours and both the drawdown and (post-pumping) recovery stages were measured manually and

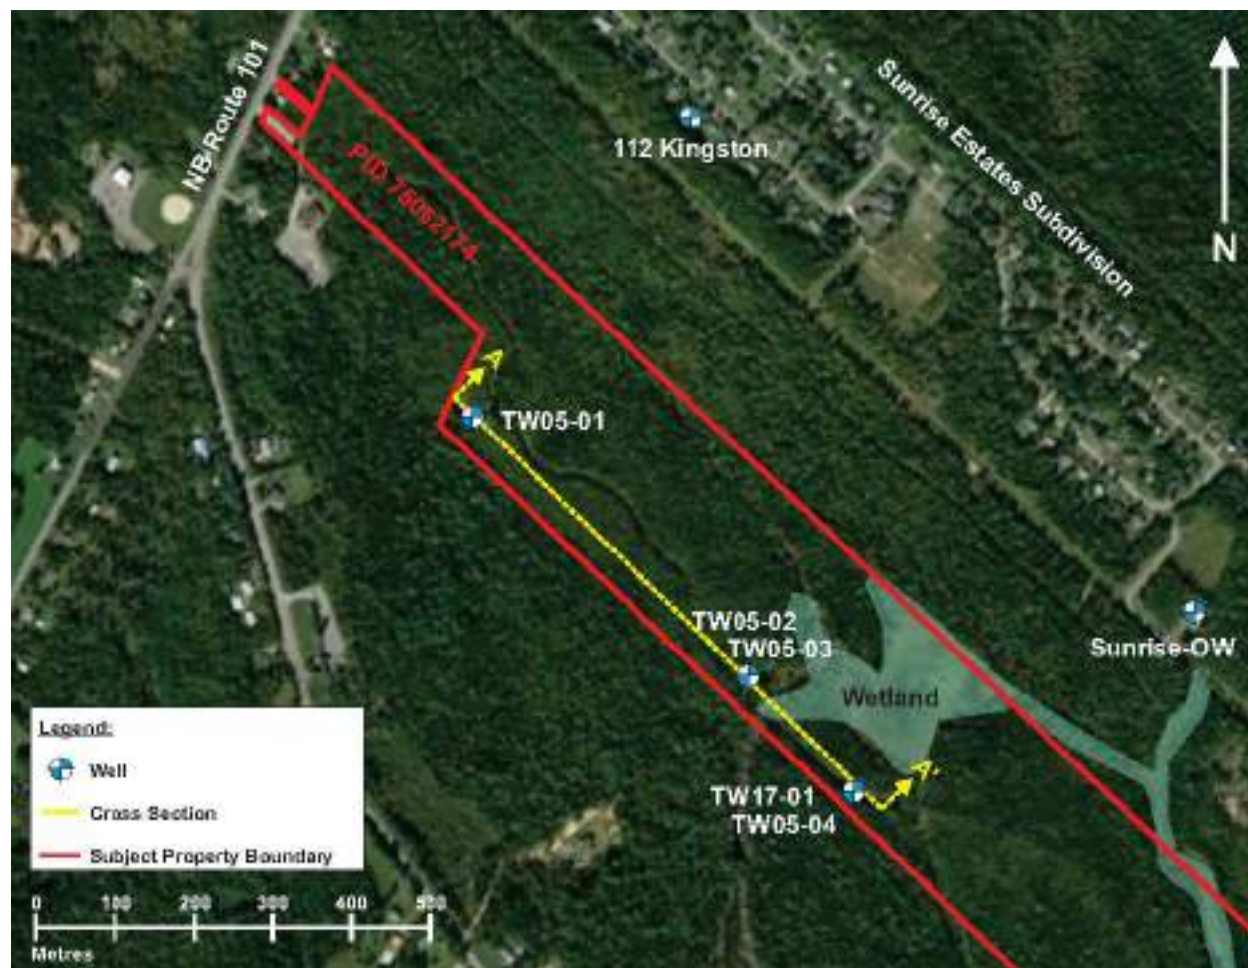
Figure 2-1. Location of test wells and monitoring wells used in this investigation.

The project site is located in the south-eastern portion of New Maryland, NB on PID 75062174 (as shown in Figure 2-1) and accessed by Route 101. The 45-hectare property is primarily composed of undeveloped, forested land, and has a wetland in the approximate centre (identified on Figure 2-1). In addition to TW17-01, there are four existing test wells located on the Property (TW05-01, TW05-02, TW05-03, and TW05-04). These test wells, along with two other observation wells located in the Sunrise Estates subdivision (Sunrise-OW and 112 Kingston), were monitored throughout the duration of the constant-rate pumping tests. Sunrise-OW is a supply well for the Village's Sanitary Pumping Station No. 2 (PID 75407429), and the Kingston well is a residential supply well for 112 Kingston Avenue (PID 75068122). Refer to Table 2-1 for a summary of construction details, and Appendix A for the available well logs.

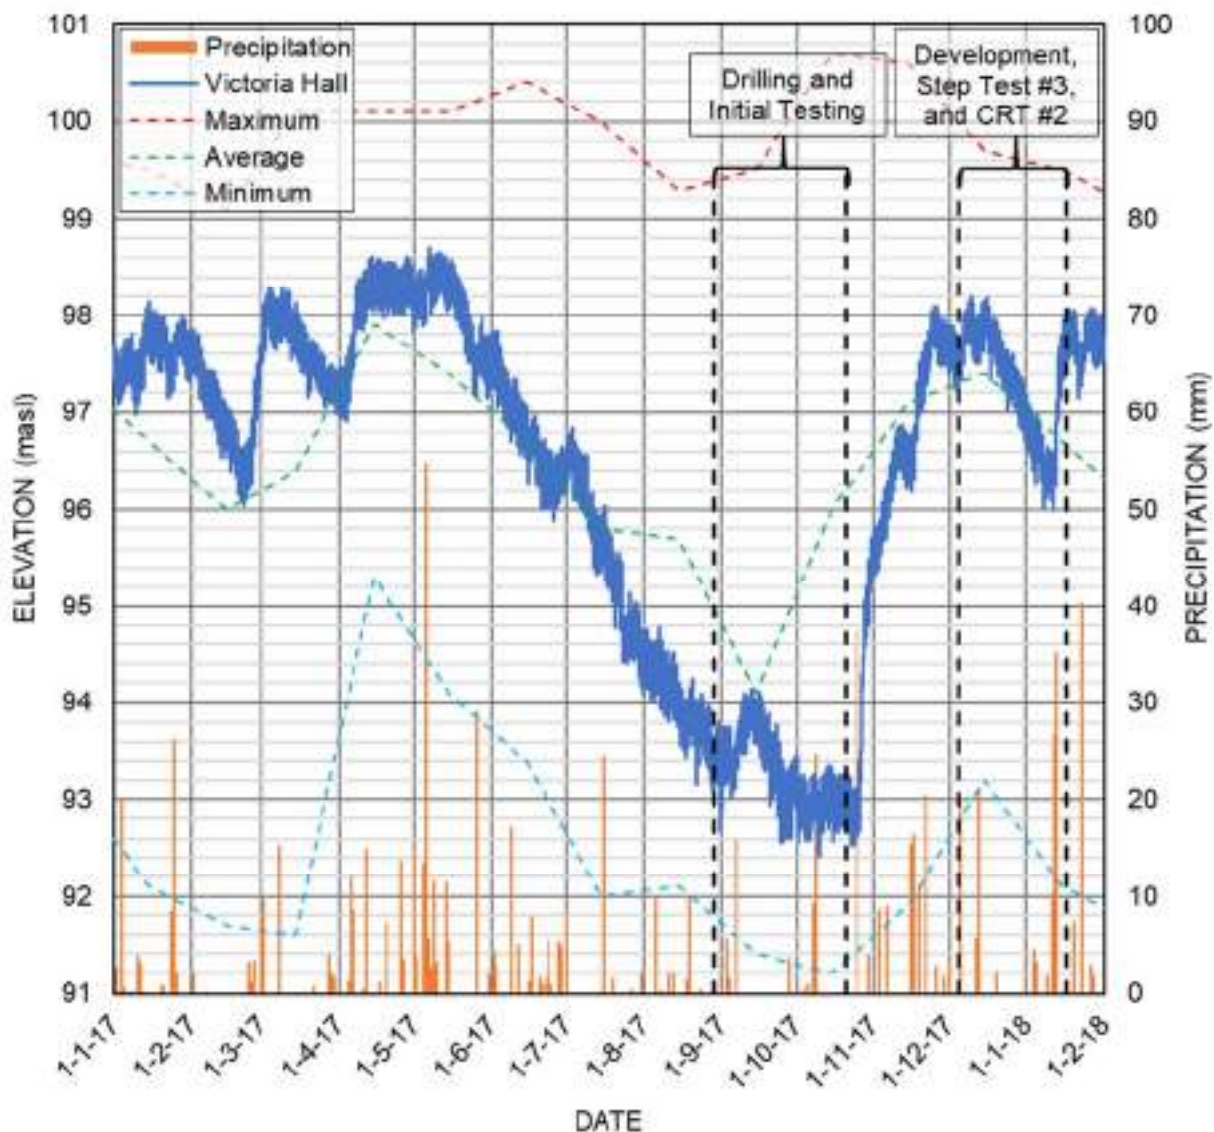
Figure 2-4. Groundwater elevations in the Victoria Hall well with precipitation.

Groundwater levels at an observation well belonging to the Provincial monitoring network, located near Victoria Hall on PID 75064253 in New Maryland, have been monitored by the Government of New Brunswick since 1979 (NBDELG 2018). The Victoria Hall well (location identified on Figure 1-1) is located approximately 2 km from the subject Property (and approximately due north from the test wells), and on ground that is approximately 40 m higher in elevation. The historical data provide some indication of general water table trends in this aquifer. From January 2017 to January 2018, groundwater levels regularly fluctuated by 1 to 2 m, with a maximum fluctuation over that period of 6 m from May to October 2017, as shown in Figure 2-4. This prolonged decline in the groundwater level confirms the extremely dry conditions under which the drilling and initial testing were completed (refer to Figure 2-4).

The extended 6-month decline in groundwater levels had resulted in levels descending below the historical (39-year) average between July and November 2017 (green dashed line in Figure 2-4). This decline is attributed to limited precipitation being received in the area over this period, (254 mm at the Fredericton International Airport monitoring station, ECCC 2018) which produced extremely dry (drought-like) conditions over these months (the precipitation is also shown in Figure 2-4 over that time period). The high variability in groundwater elevations measured at the Victoria Hall well, up to 10 m between the historical maximum and minimum water levels over the period of record (red and blue dashed lines, respectively), suggests that this aquifer is highly influenced by precipitation and snowmelt (with a time lag² of 5 days for its effects to reach the aquifer), and the antecedent moisture condition.

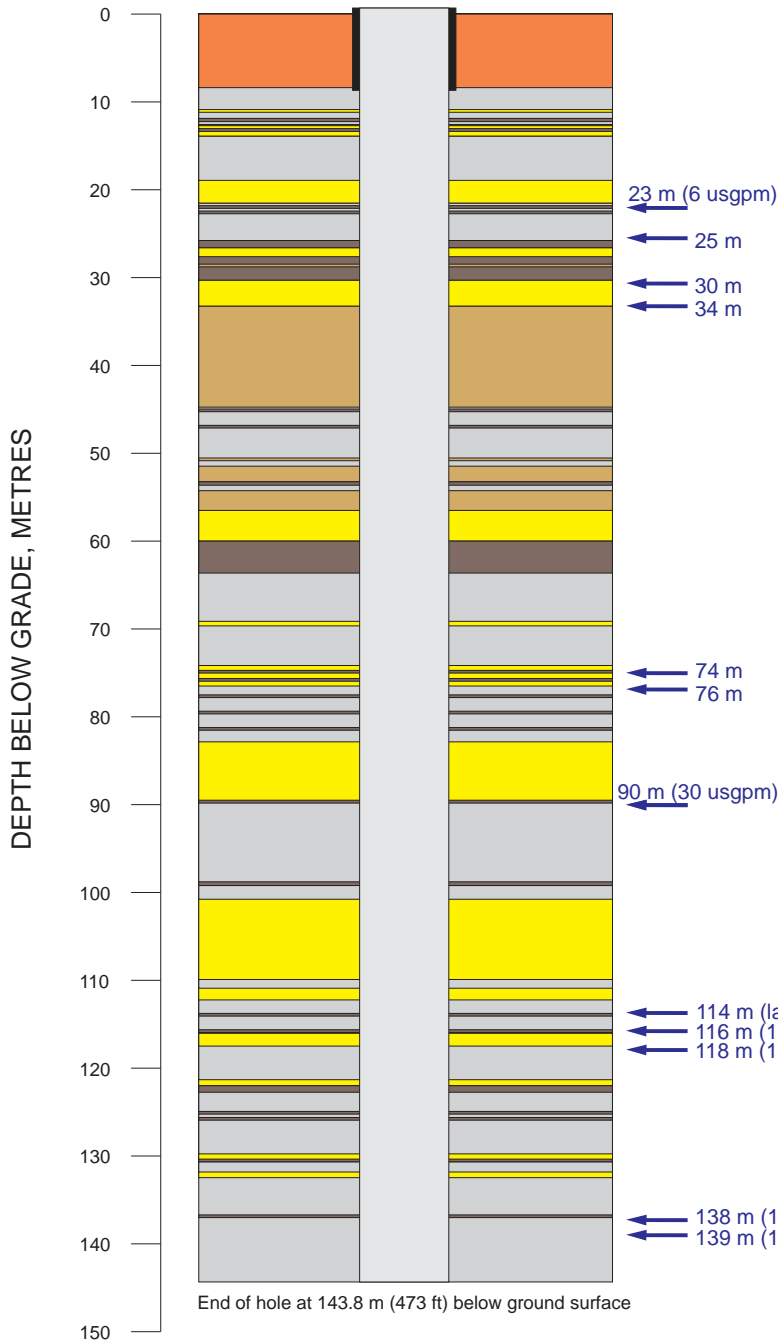
TEST WELL TW05-04 CONSTRUCTION DETAILS (AS OF JULY 11, 2017):

150 mm (6-inch) diameter steel casing with drive-shoe
installed to 7.6 m (25 ft) below ground surface
(casing stick-up = 0.62 m (2 ft) above ground surface)

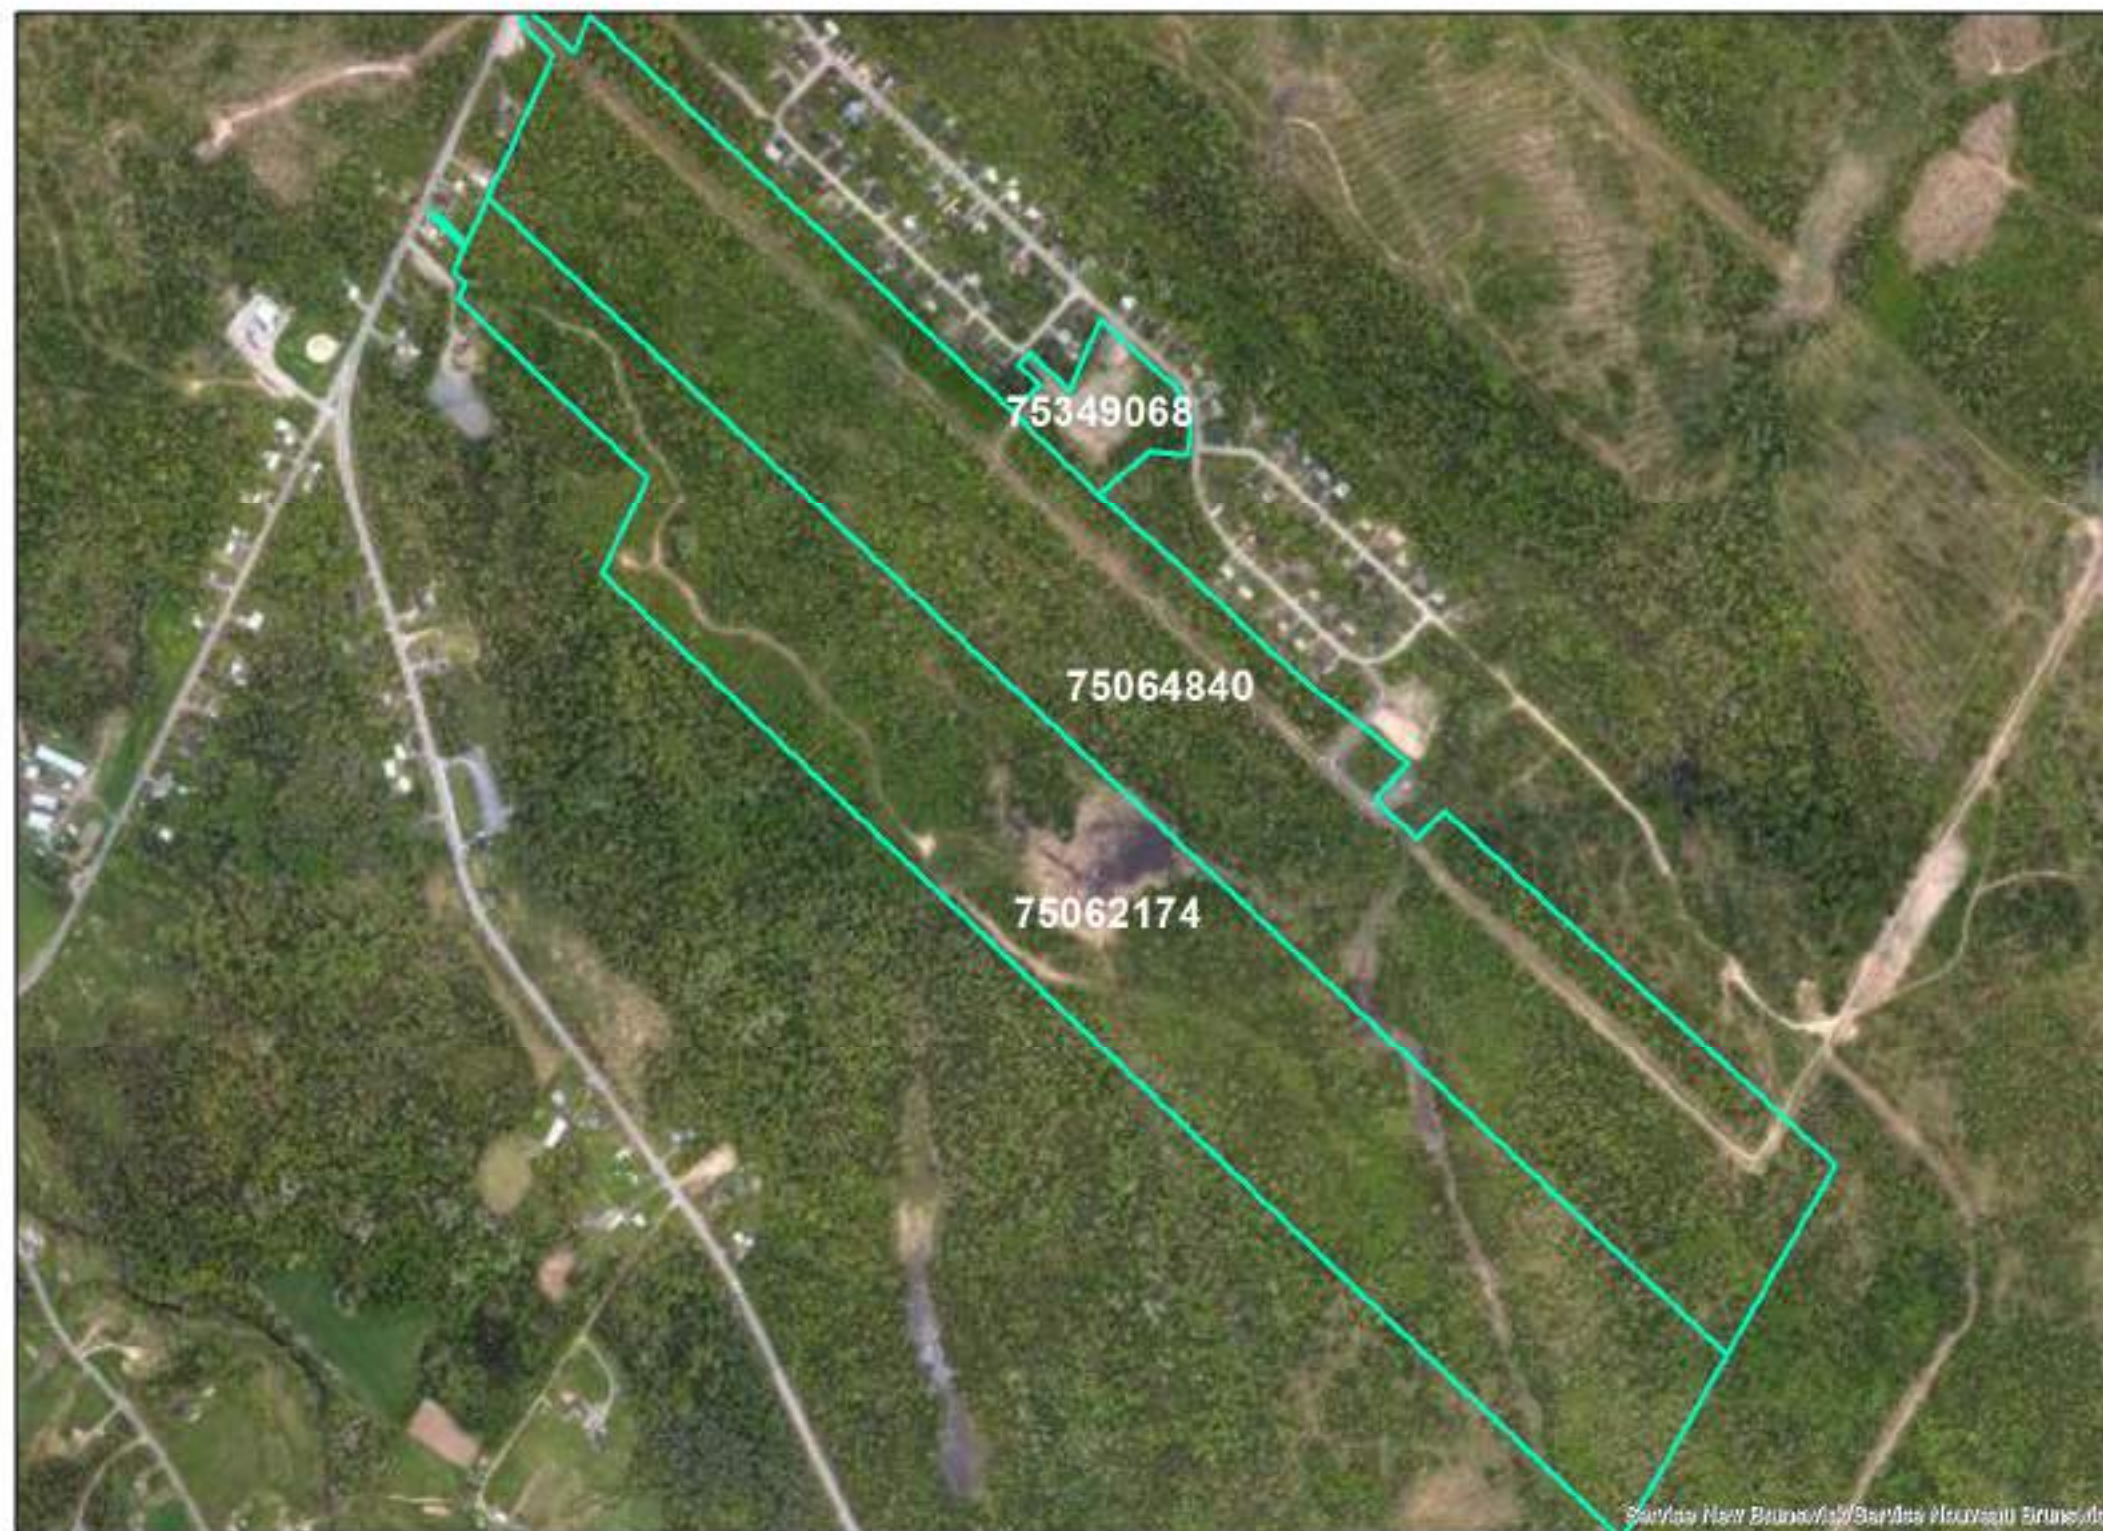
Figure 1

Project Location
Village of New Maryland

Boreal Environmental (Boreal) was contracted by WSP, in June of 2018 to conduct wetland, bird, and rare plant survey on the site of a proposed wellfield development site (PID 75062174, 75064840, 75349068) in the Village of New Maryland, New Brunswick (Figure 1). The purpose of the environmental constraints analysis was to determine location of to develop a wellfield in order to provide adequate water supply to the Village of New Maryland. The primary objective of these surveys was to determine if rare species and/or wetlands were present within the Project Area.

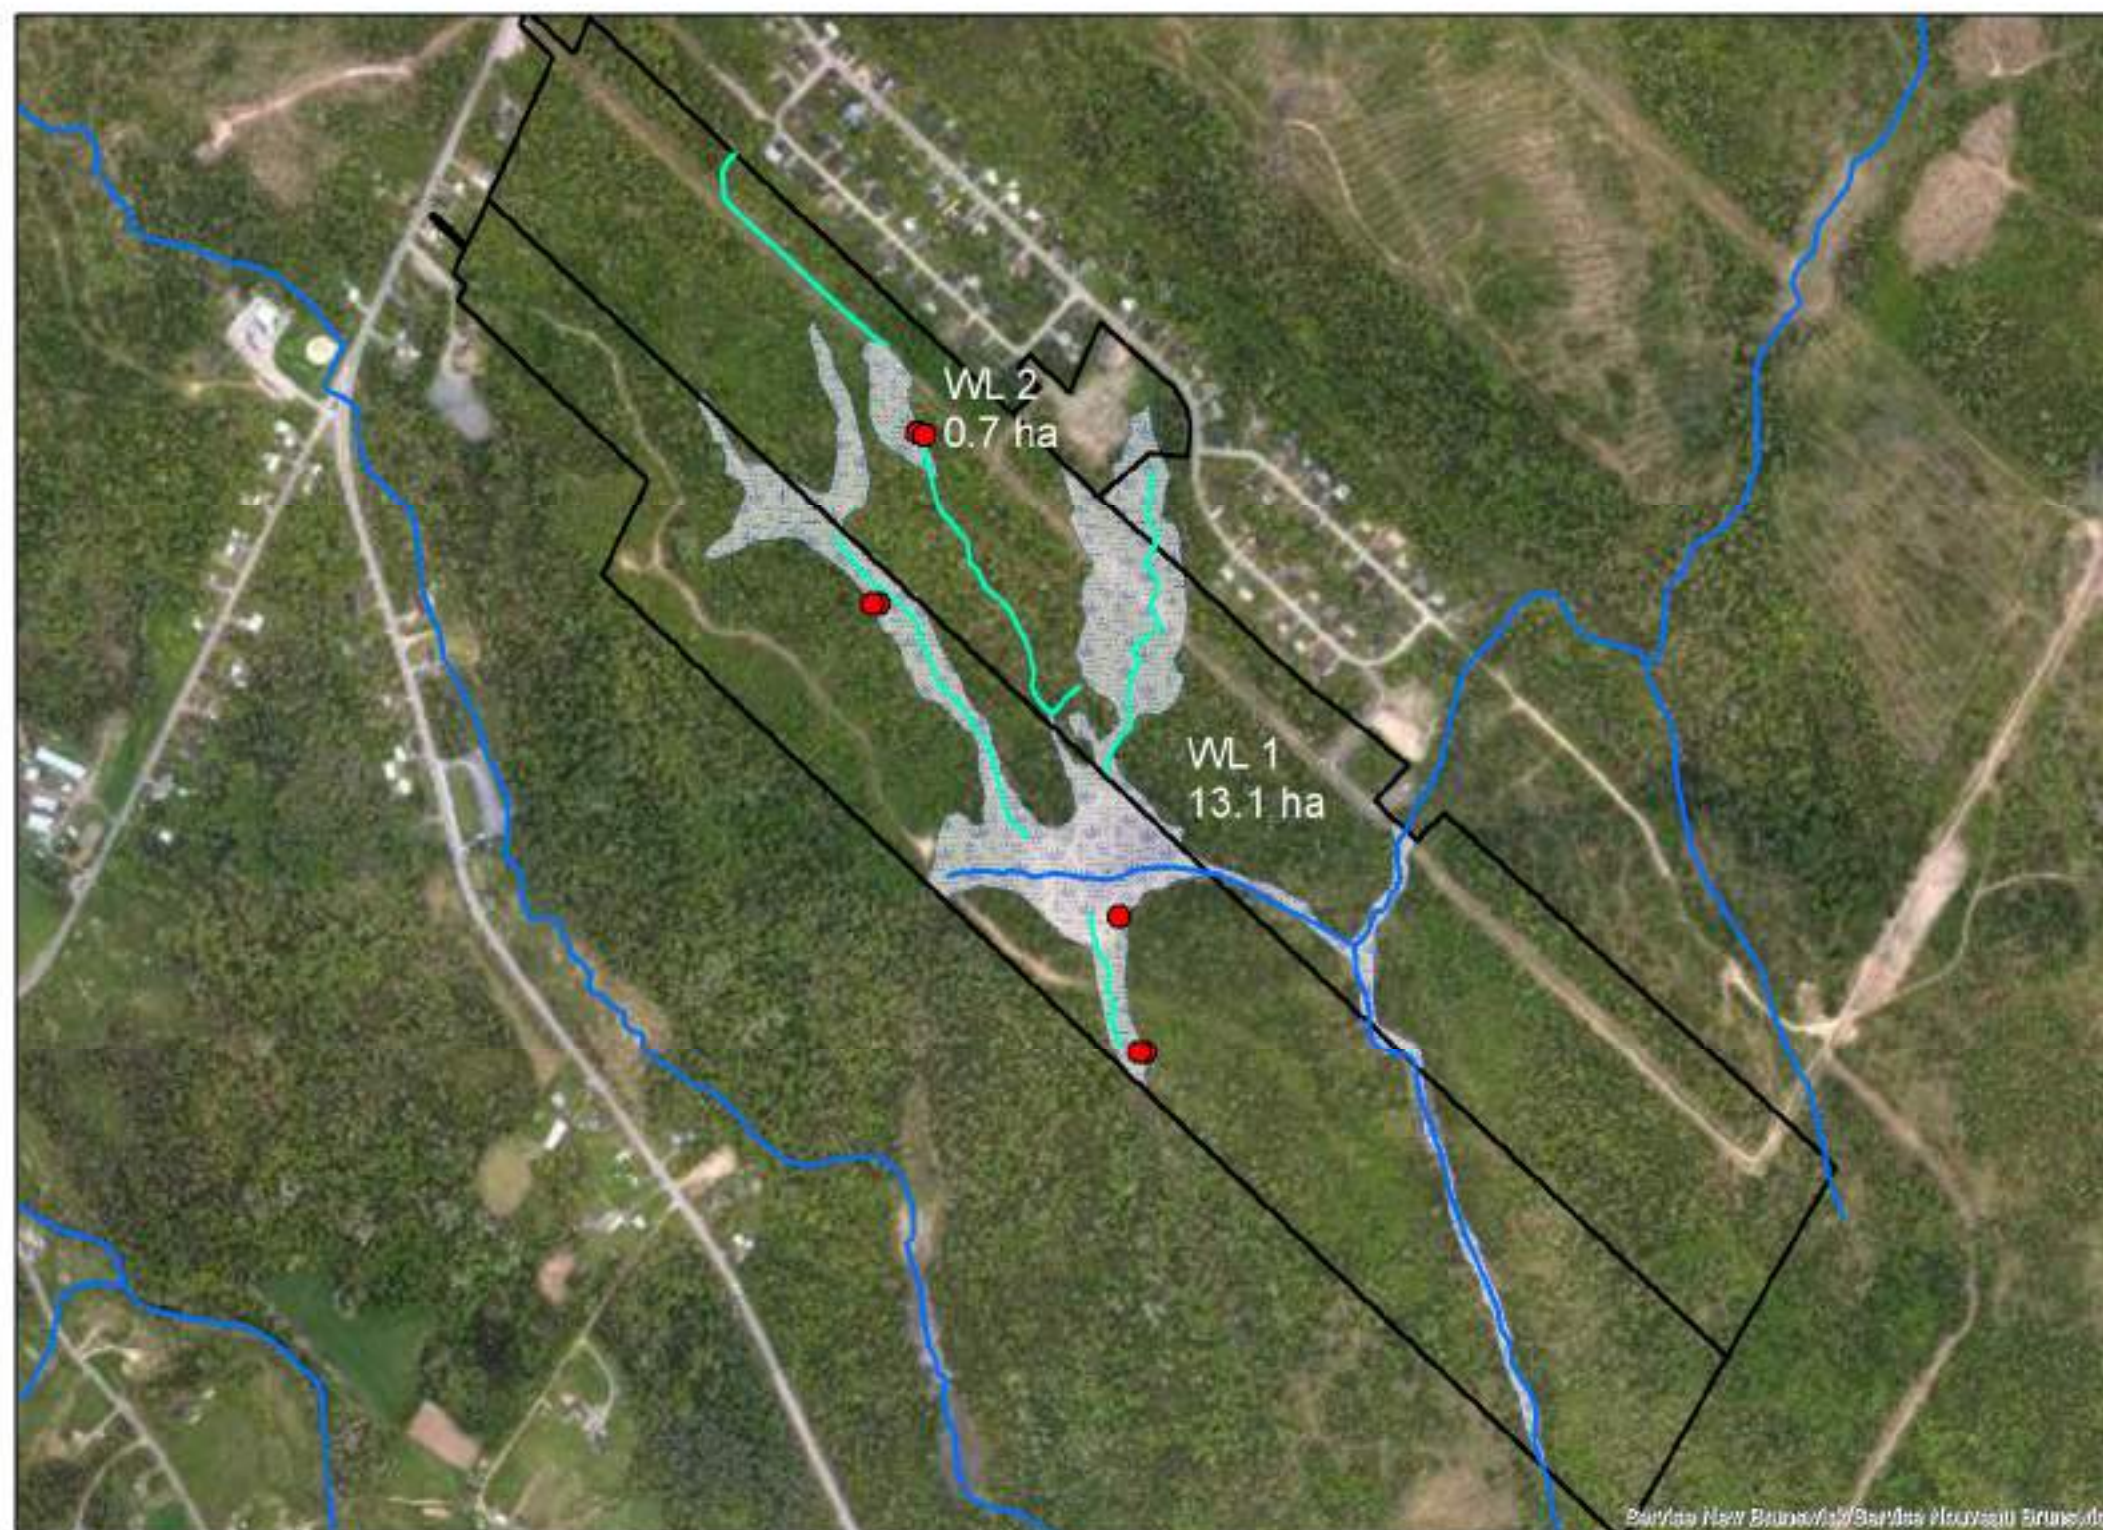
Figure 3

Wetland and Watercourse Village of New Maryland

Two unmapped wetlands, WL 1 and WL 2, were identified on the subject property. They were determined to be forested swamps of various types (Figure 3). WL 1 swamp complex 13.1 ha in size consisting of forested riverene swamp, forested slope swamp and sedge/reed riparian swamp. Several small unmapped intermittent and permanent watercourses flow through WL 1 which discharge to a mapped watercourse in the southeastern portion of the property. WL 2 was determined to be a deciduous treed riverene swamp. The watercourse that flows through WL 2 discharges to WL 1. Representative photographs of plant communities within each wetland are provided in Appendix VI.

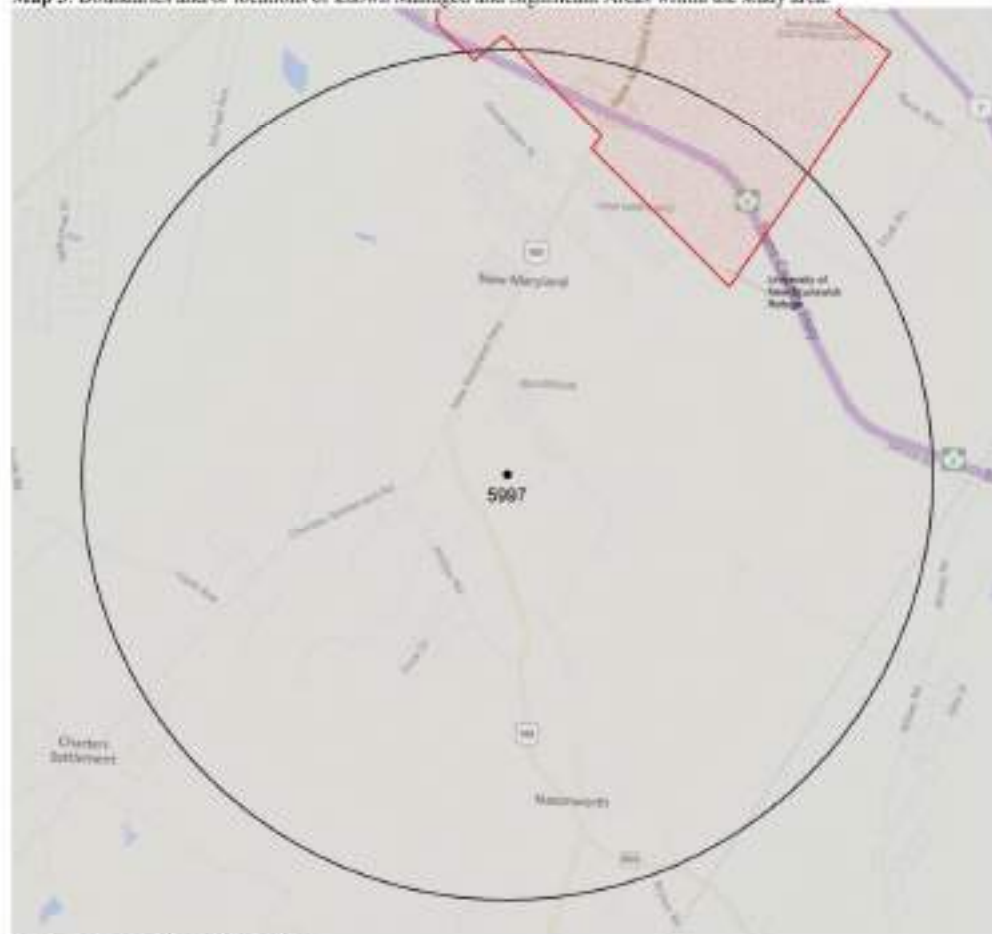
Map 3: Boundaries and/or locations of known Managed and Significant Areas within the study area.

The GIS scan identified no biologically significant sites in the vicinity of the study area (Map 3).

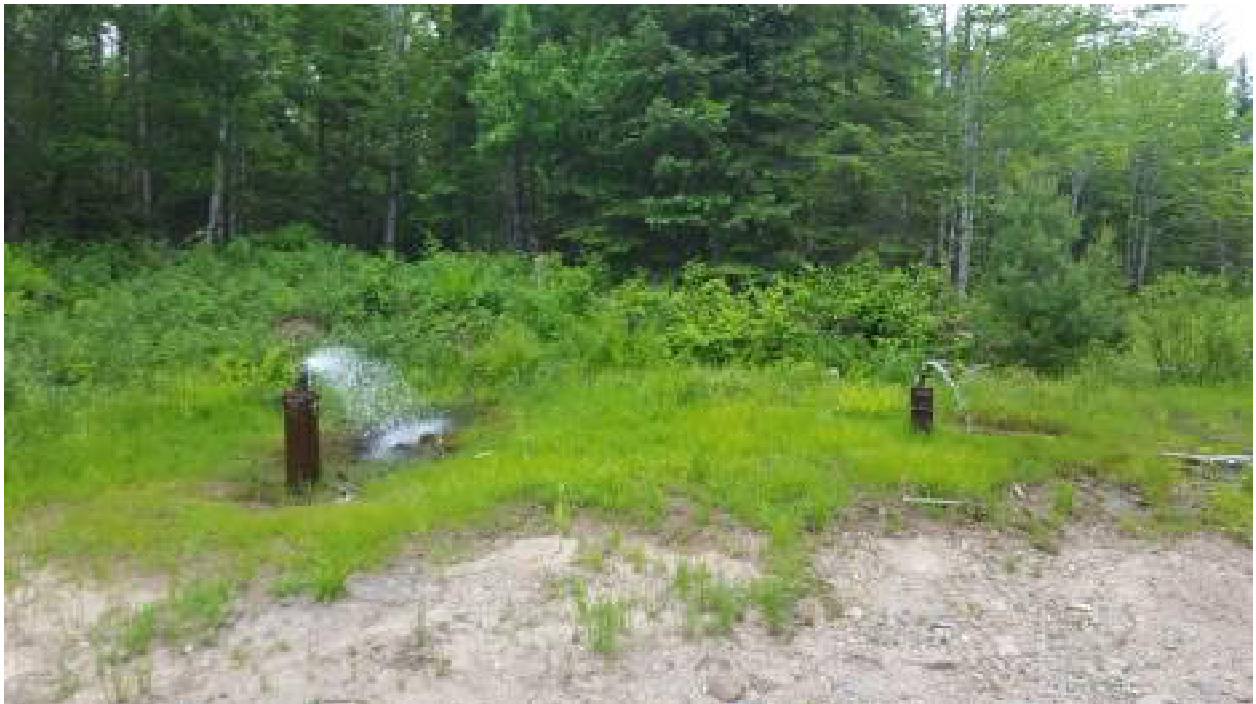
Photo 1. Test wells located along access road and adjacent to the west central portion of Wetland 1.

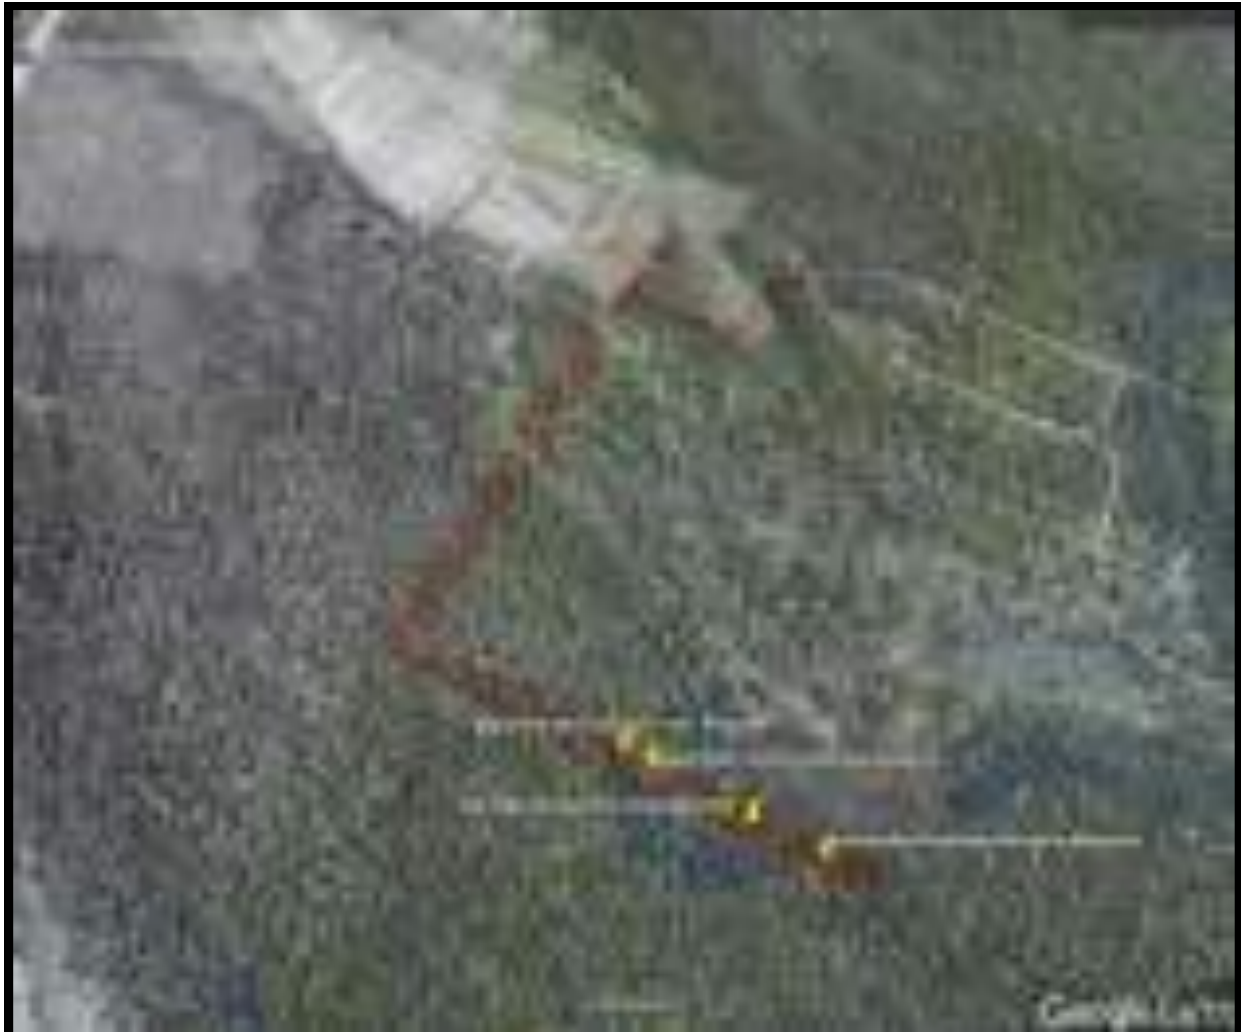
**Overlay of Project-Related Infrastructure on
Historical Aerial Photograph (A8237/100),
dating to 4 July 1945.**

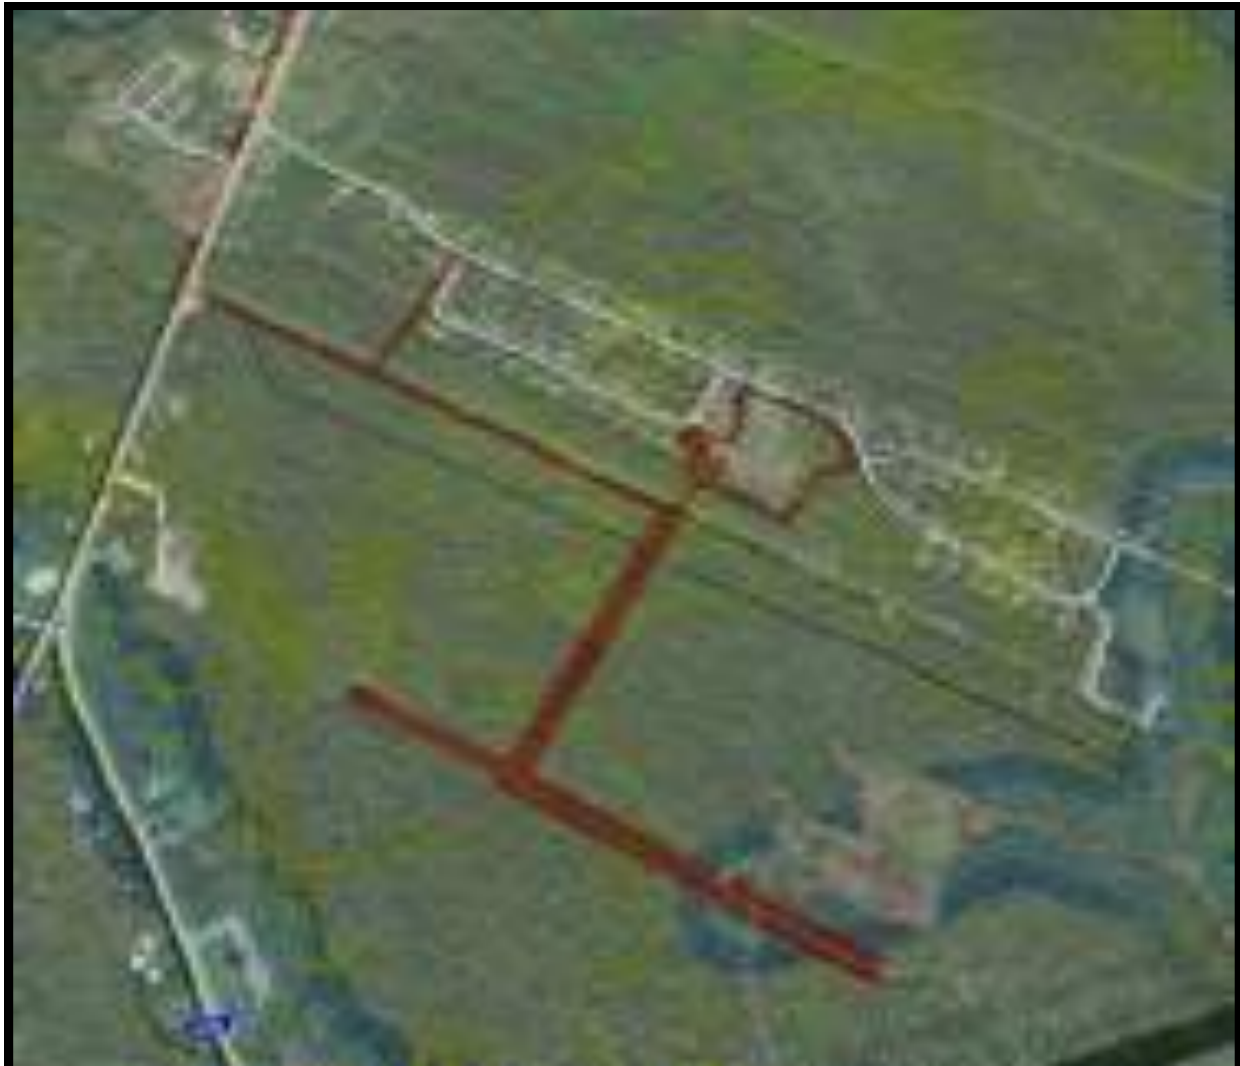
Overlay of Archaeological Potential Model on contemporary Google Earth Pro imagery.
Transmission pipeline route is along existing road near unnamed tributary to Burpee Brook.

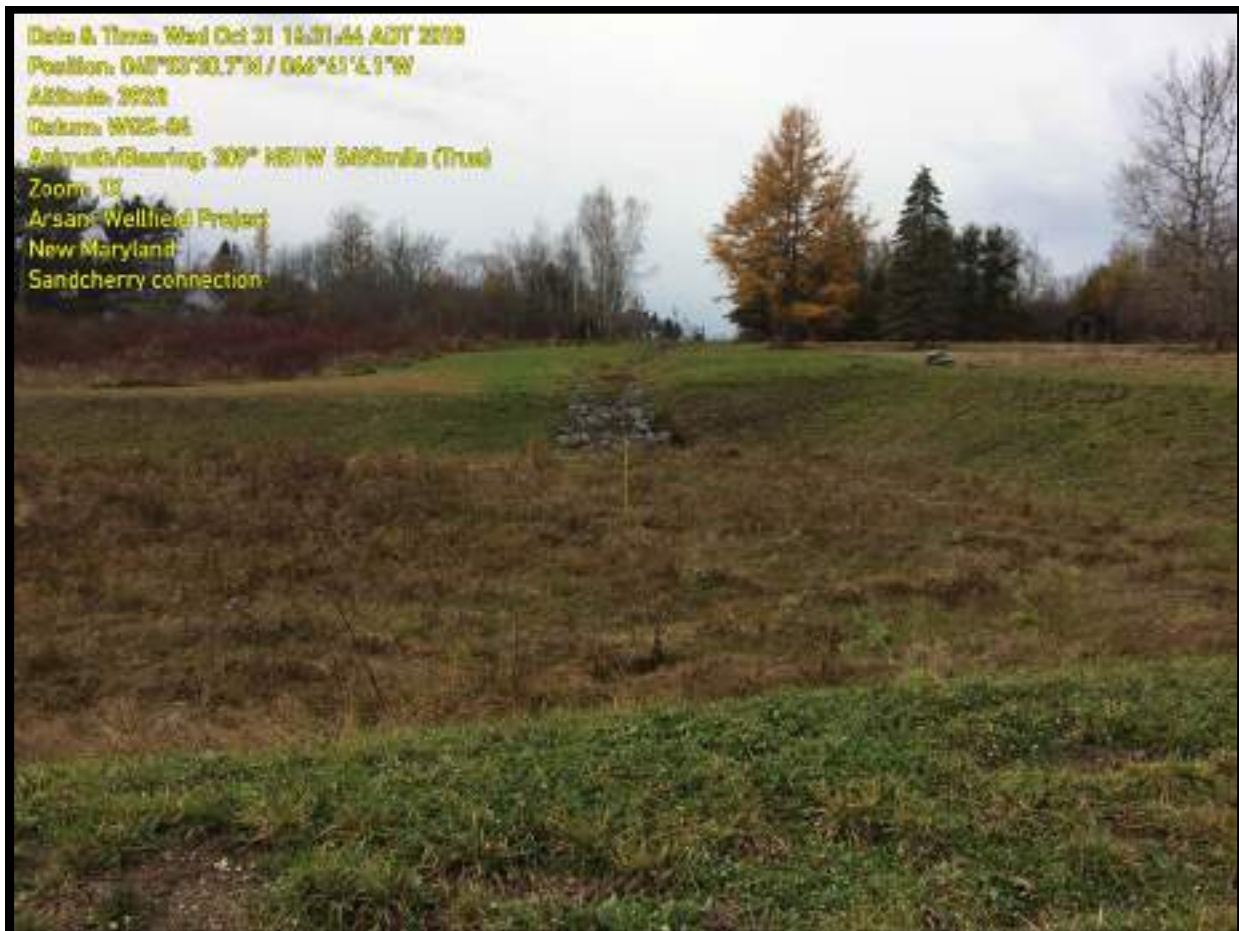
Existing storm water attenuation feature
near Sandcherry connection.

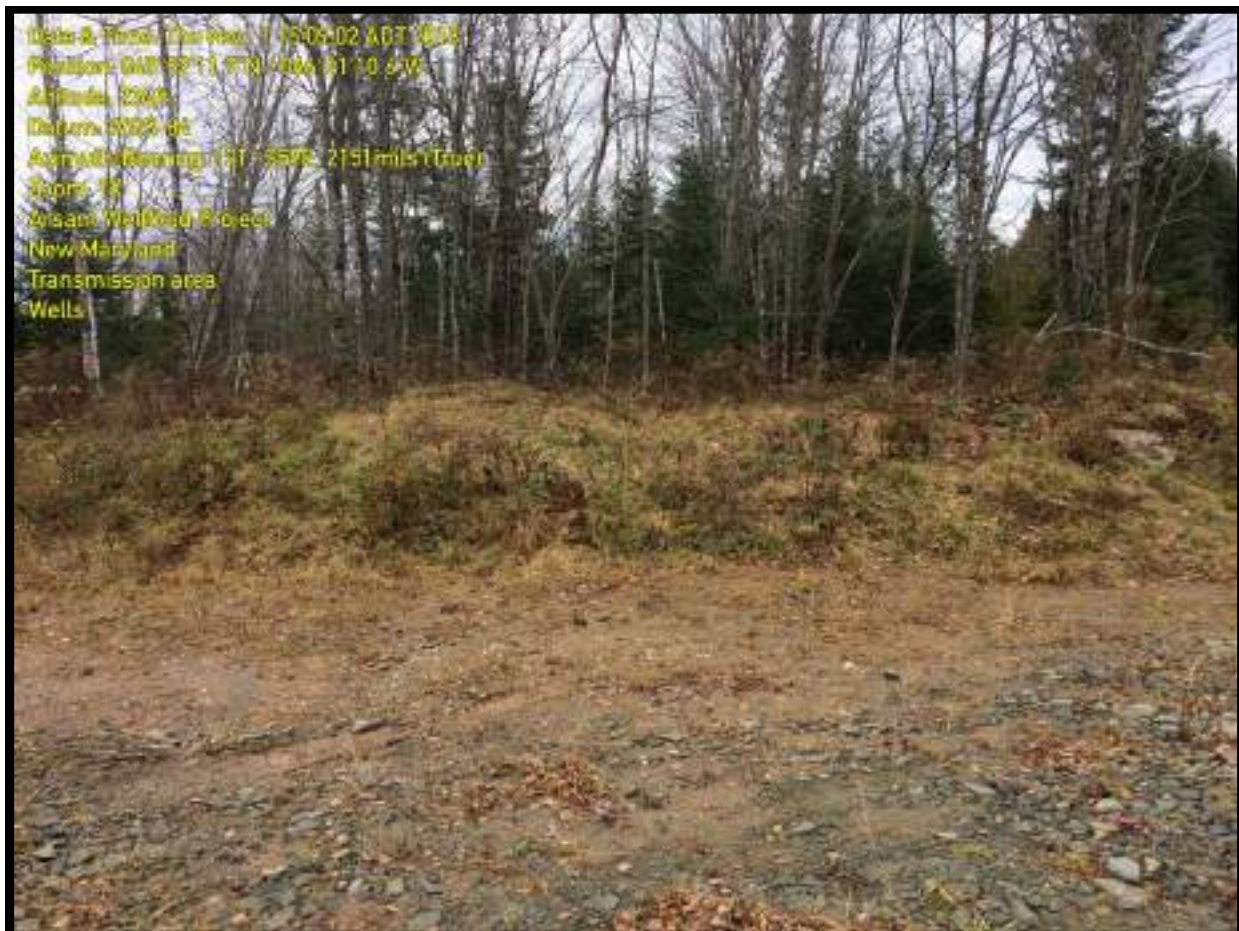
Existing ground disturbance and push-ups near existing wells.	 
Village of New Maryland Arsam Property Wellfield Development	Photo No.: B14
Client: WSP Canada	Source: Stratis

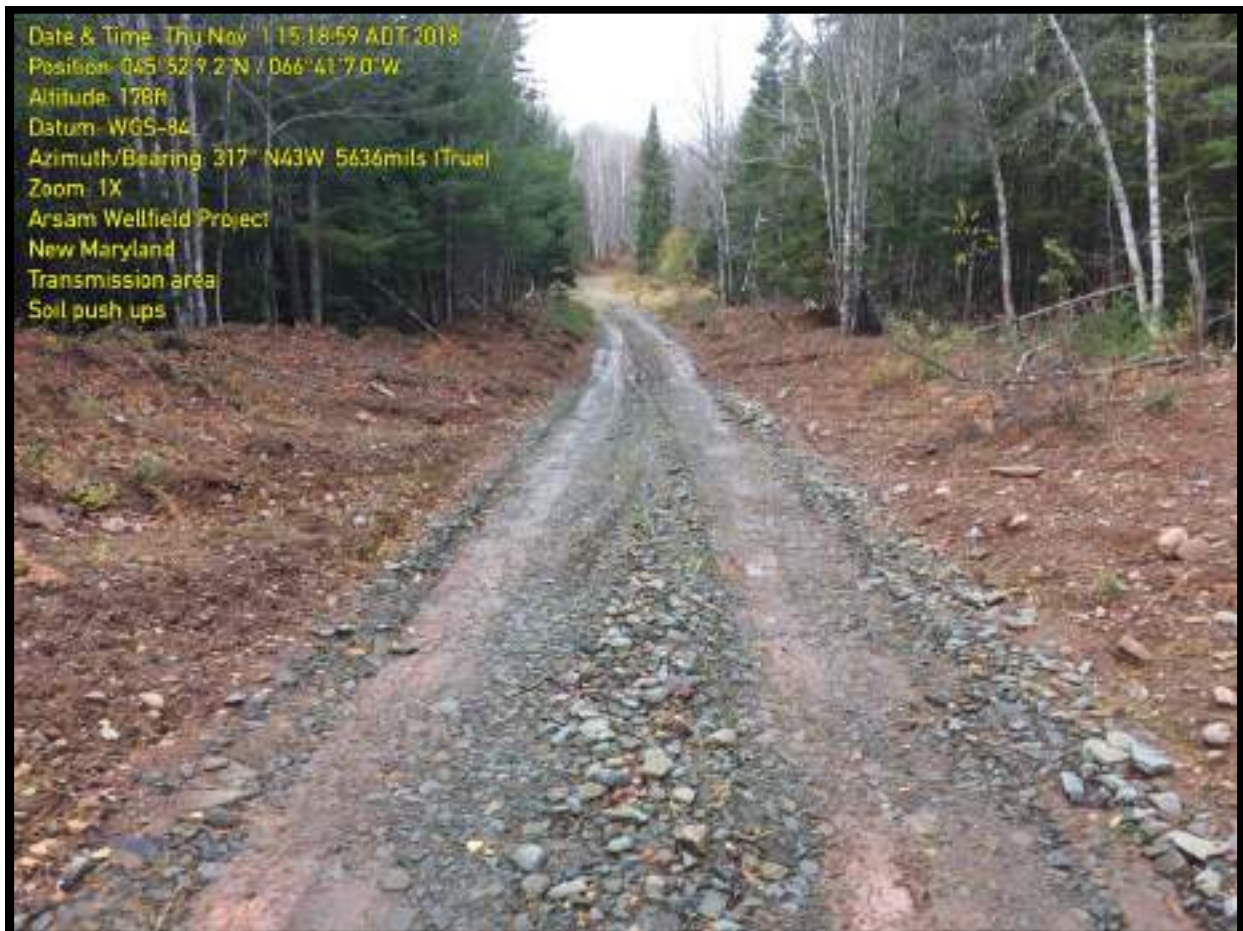
Soil push-up disturbance along existing road in Transmission Pipeline RoW.	 
Village of New Maryland Arsam Property Wellfield Development	Photo No.: B15
Client: WSP Canada	Source: Stratis
